**INDIVIDUAL PROPERTY/DISTRICT
MARYLAND HISTORICAL TRUST
INTERNAL NR-ELIGIBILITY REVIEW FORM**

Property/District Name: David Reindollar Farm Survey Number: CARR-1461

**Maryland Historical Trust
State Historic Sites Inventory Form**

historic David Reindollar Farm

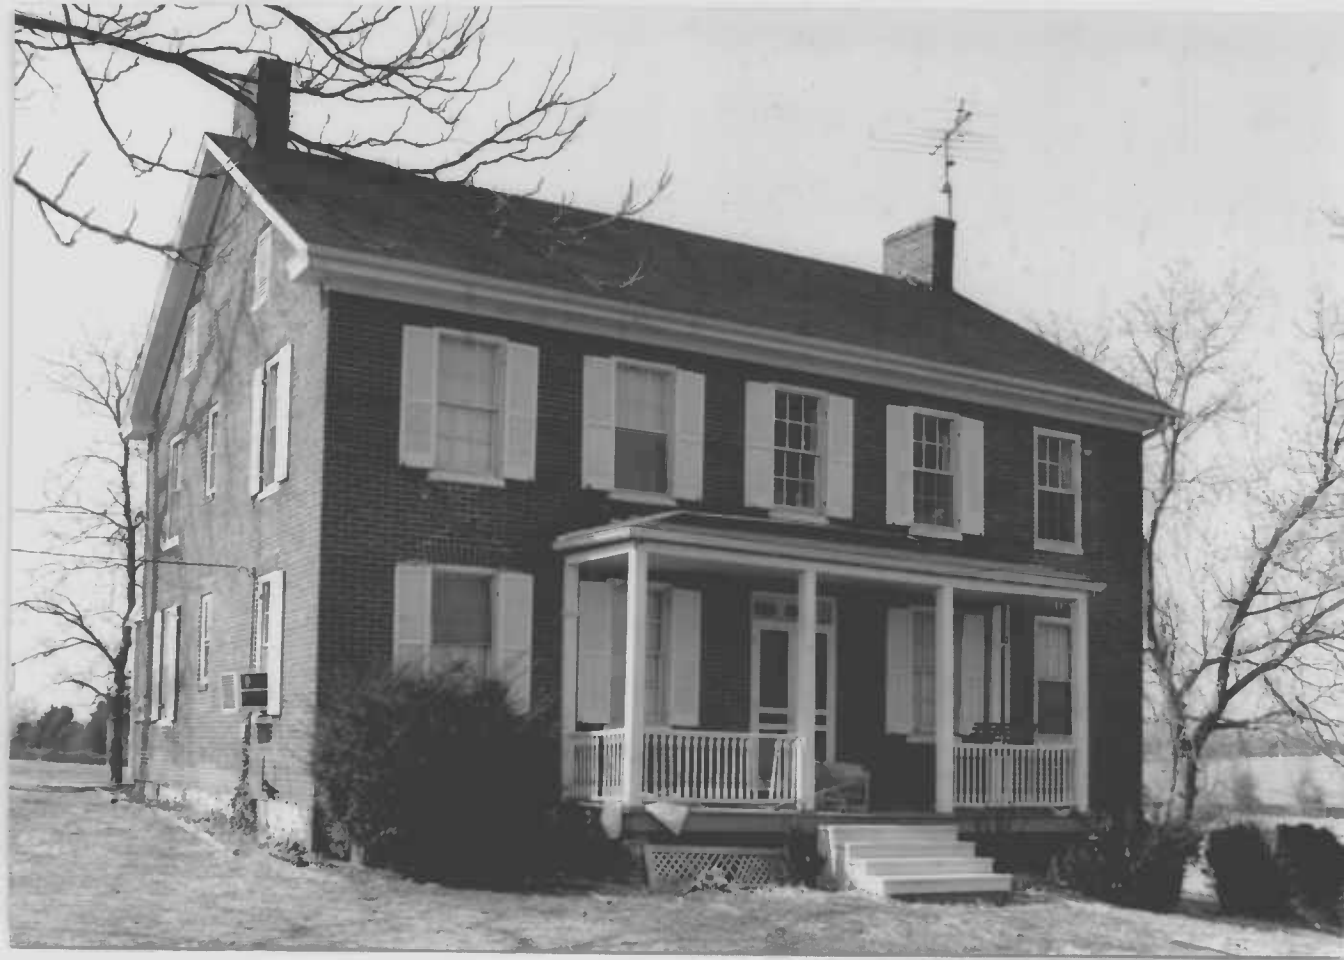
1/8

Neg. Loc.: Maryland Historical Trust
SE elev.

The house faces southeast toward the road and is a two-story, five-bay by two-bay structure, with a rubble stone foundation of local brownstone, running bond brick on the south elevation, and 7-to-1 common bond brick on the rest of the elevations. There are traces of penciling, but it appears that the brick was not painted, only the joints were penciled. The house has a gable roof of asphalt shingles with a northeast-southwest ridge. There is a wood box cornice with returns, and the bed mould has a fascia. There is an interior brick chimney on each end.

of the foundation, and a 2/2 double-hung sash in the east bay. The first story has a center entrance with double doors, each having four panels with bolection mouldings. The door jambs have two panels. There is a two-oval-light transom, and the jamb and soffit have one panel each. There is a brownstone lug sill and splayed brick jack arch. On either side of the doorway are two 6/6 double-hung sash. The top sash are fixed. The sills are wood, and there are splayed brick jack arches. They have blinds, and the bottom half of them are adjustable. There is a one-story, three-bay porch with new railings and a half-hip roof with asphalt shingles. There are four square posts. The porch formerly had brackets. The second story has five typical 6/6 sash.

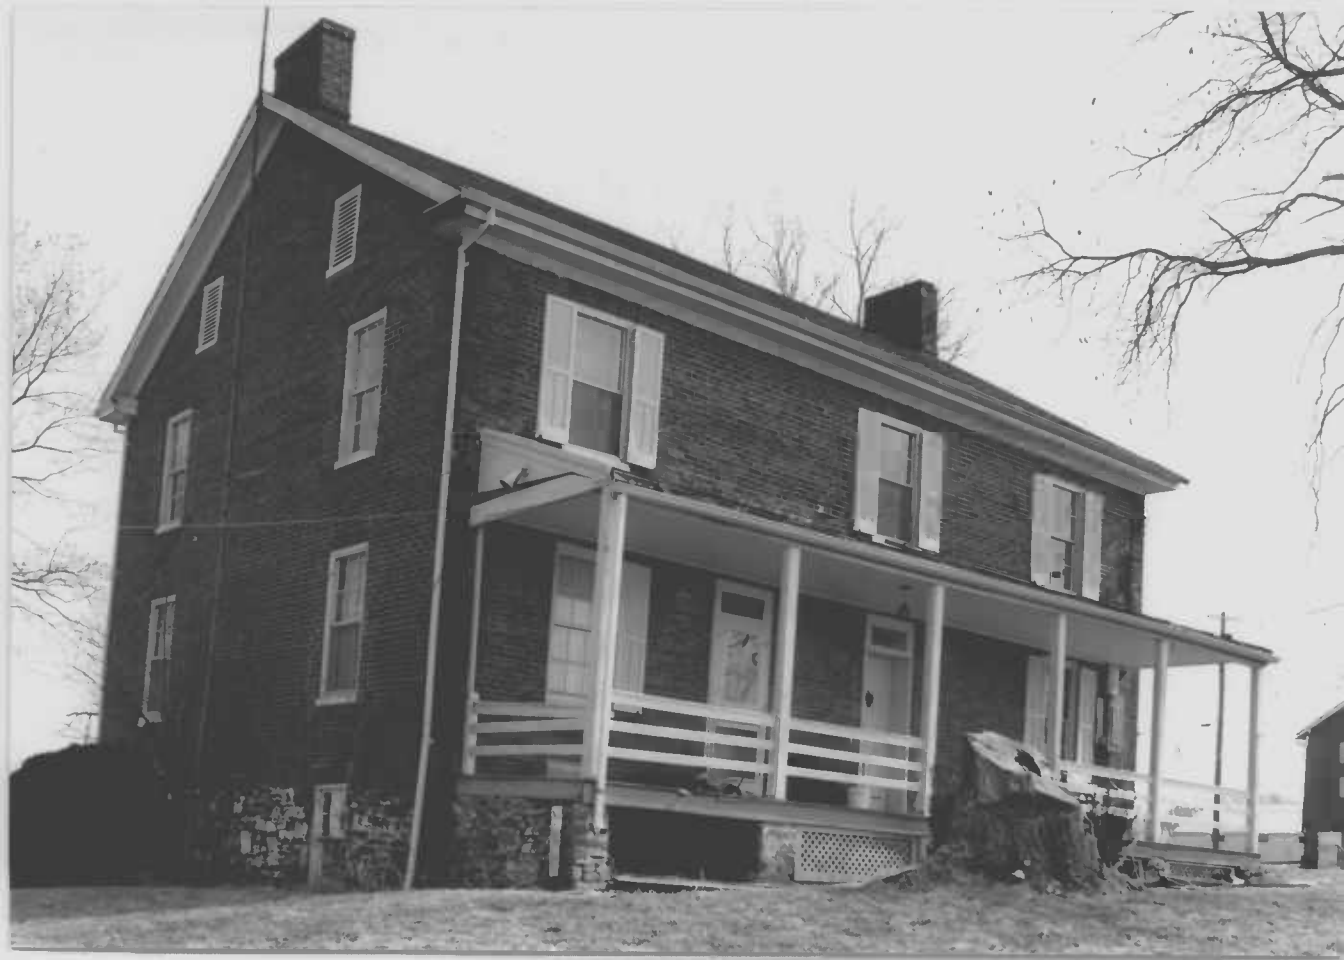
$\frac{3}{8}$

Neg. loc.: Maryland Historical Trust
NE & NW elevs.

On the northwest elevation, the first story has, from west to north, a typical 6/6 sash, a door with two lights over two panels and a four-light transom, a door with four panels and a four-light transom, no opening, and a typical 6/6 sash. There is a five-bay, one-story porch, with a shed roof of standing-seam metal, and six posts with three horizontal rails between them. The second story has three typical 6/6 sash, one each in the end bays and the center bay. The cornice is identical to the southeast elevation.

The northeast elevation has a beaded-edge, vertical-board door with a four-light sash in the east bay of the foundation. The north bay has a typical 6/6 sash. The first and second stories have two typical 6/6 sash. The gable end has two typical wood louvered vents.

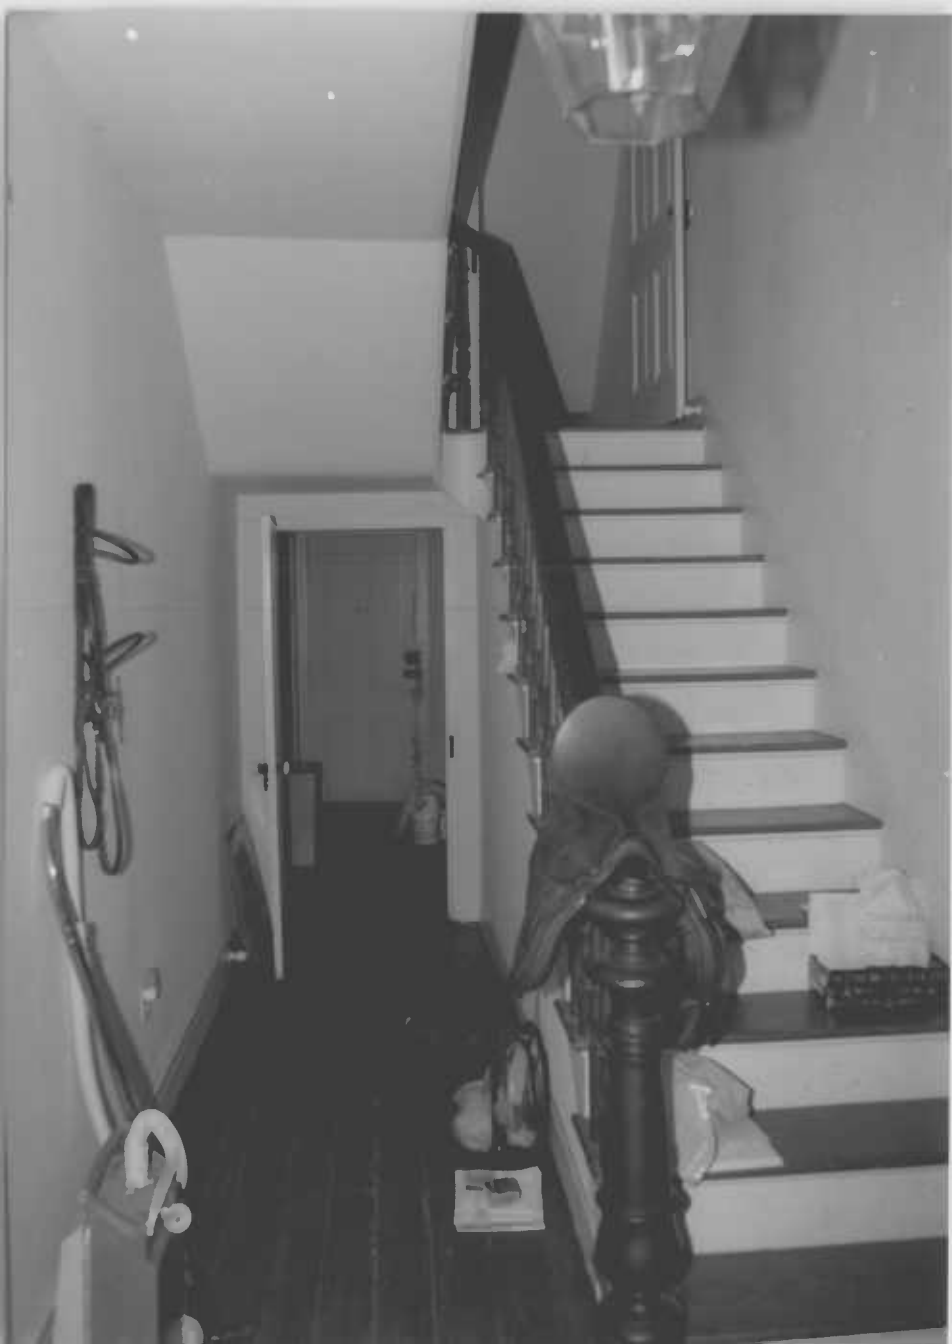
3/8

Neg. Loc.: Maryland Historical Trust
Passage - view NW

The first story has a center-passage, double-pile plan. The flooring is tongue-and-grooved pine that runs northwest-southeast throughout the house. It is face-nailed with cut nails. The center passage has a dog-leg stair on the northeast wall that has an open stringer, turned oak balusters, and a turned newel. The northeast wall is brick with plaster on it. The interior doors have four panels. The passage is divided in half by a wall with a four-panel

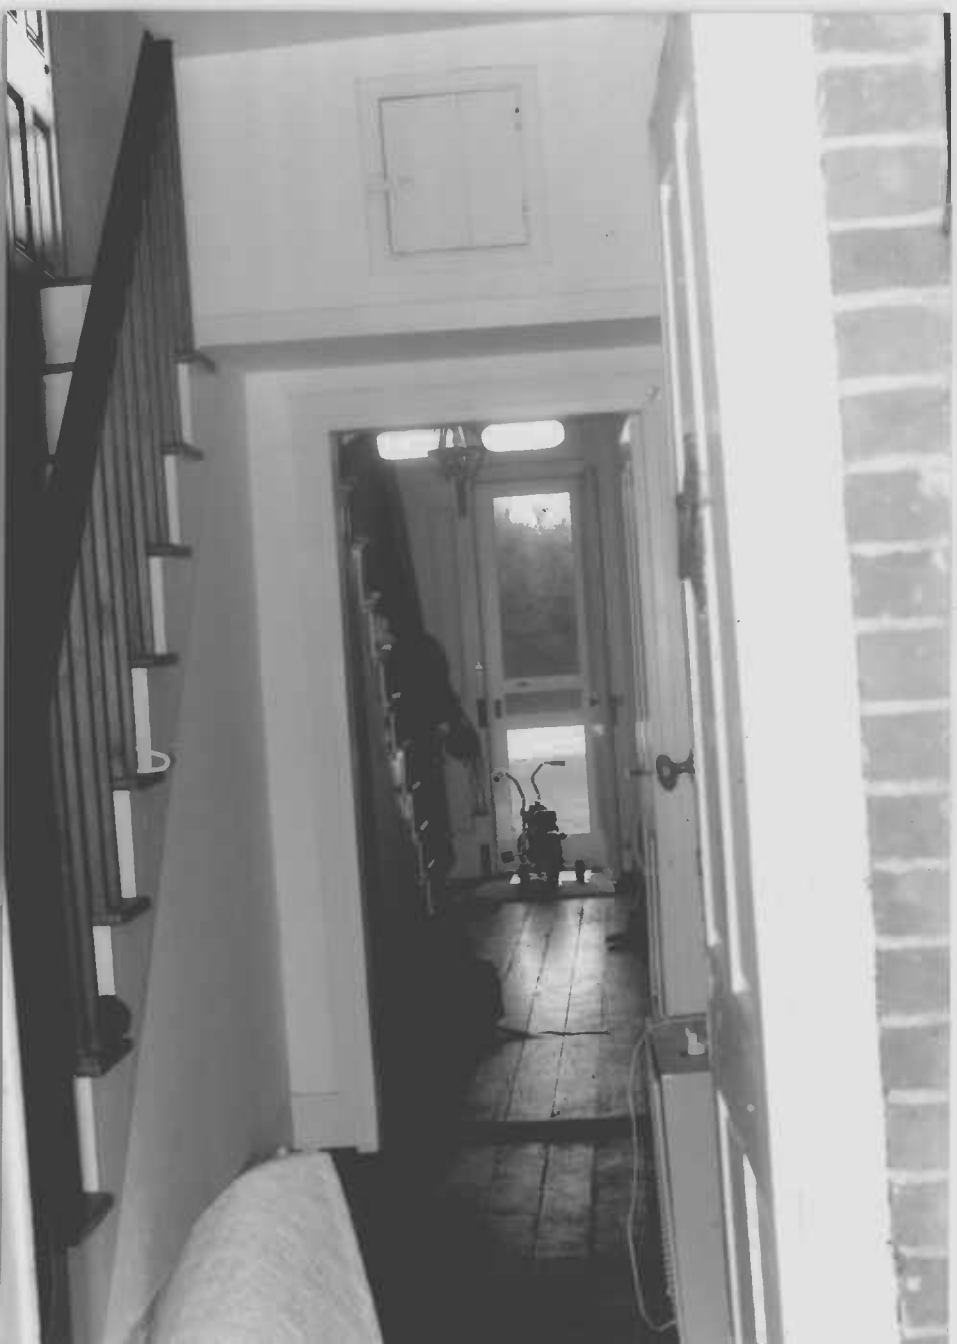
4/8

Neg. Loc.: Maryland Historical Trust
passage - view NW

door. The northwest side of the passage has an open stringer, two-flight stair along the northeast wall with a landing along the southeast and stairs that continue to the northeast. This stairway has rectangular balusters and a simpler turned newel.

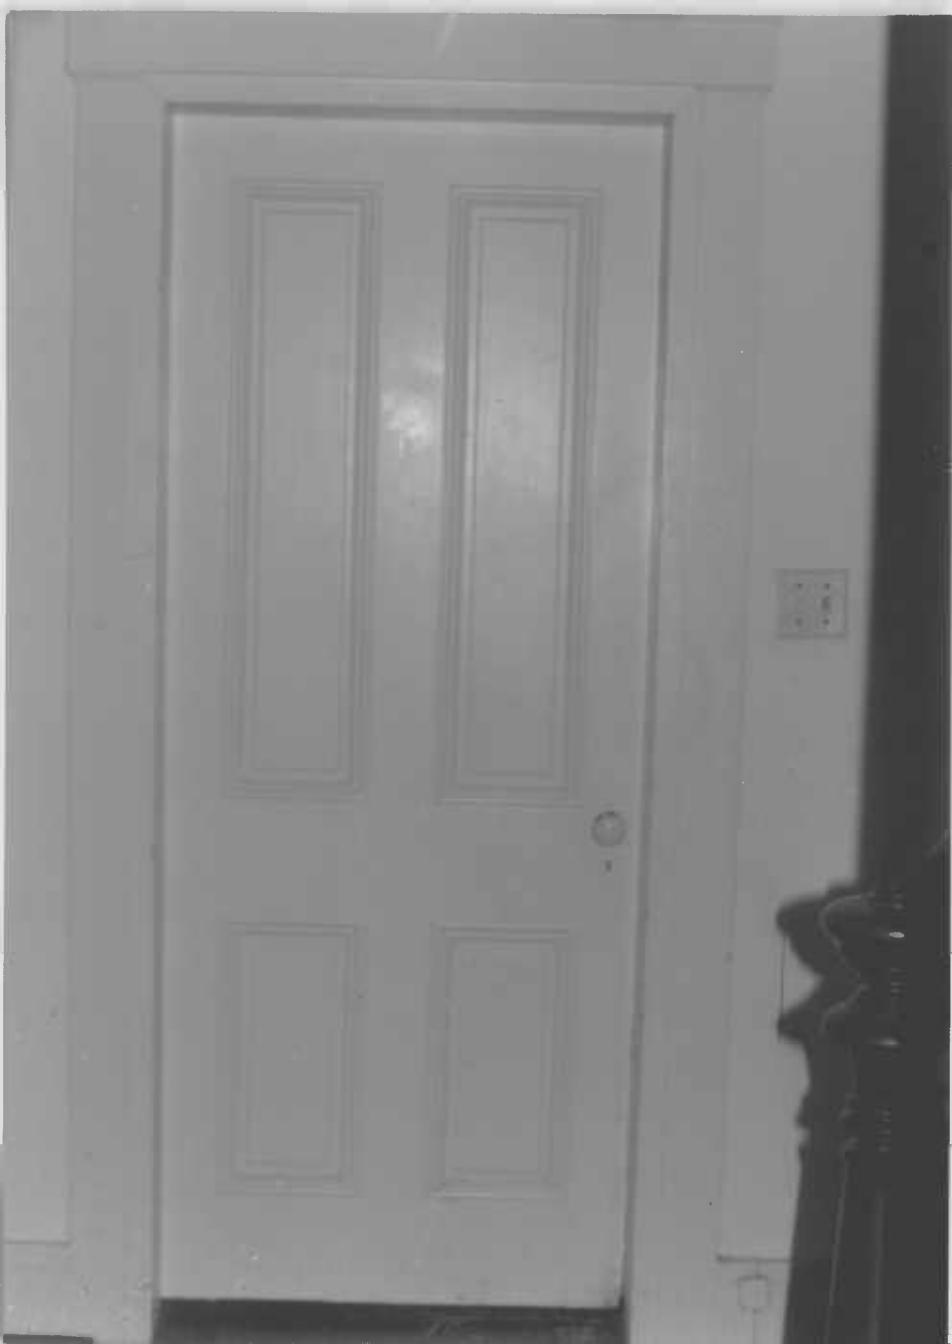
5/8

Neg. Loc.: Maryland Historical Trust.
door architrave

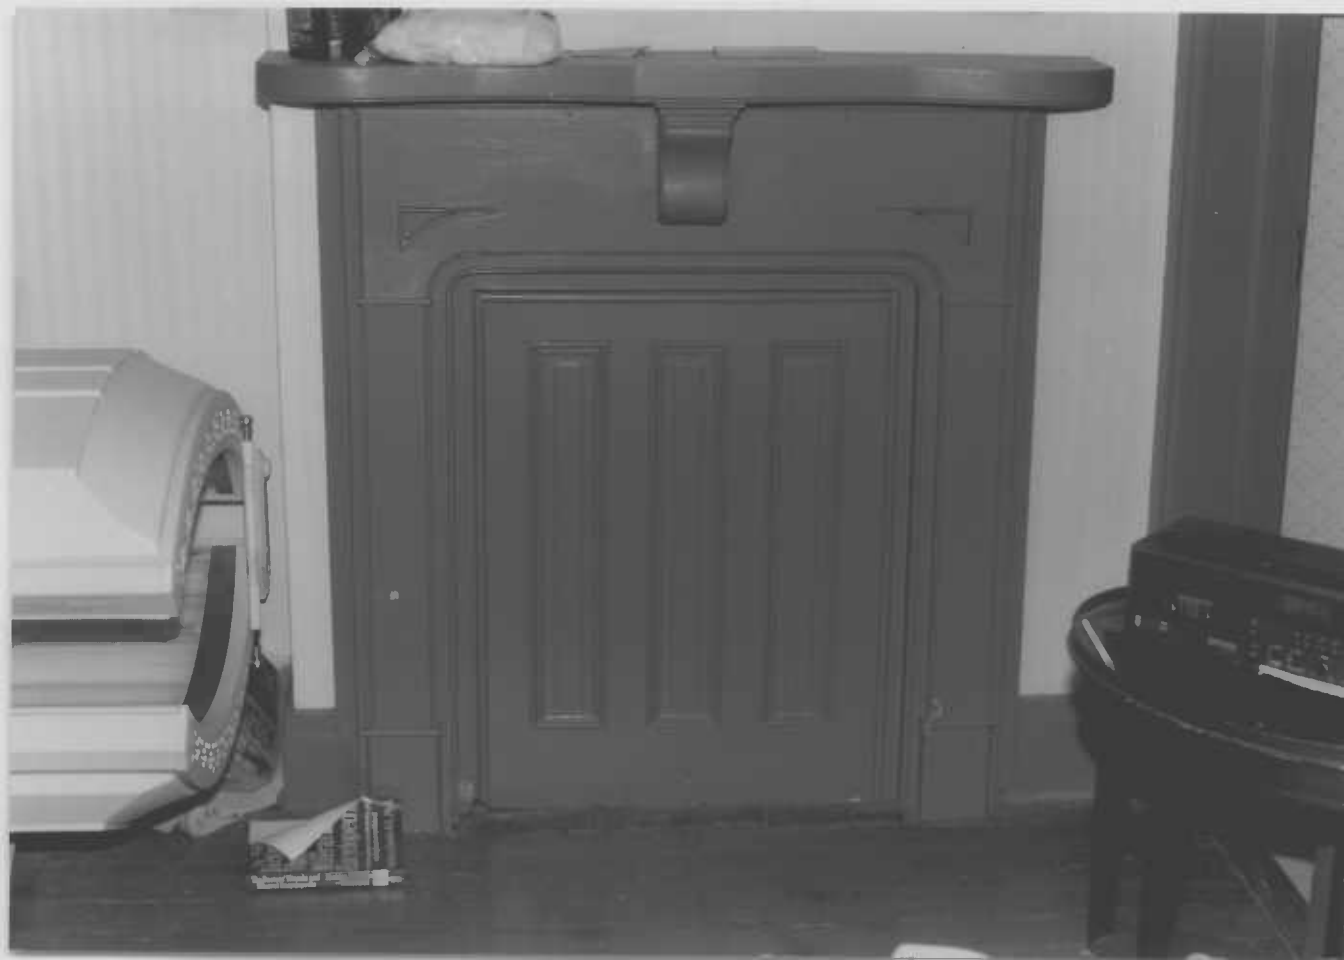
6/8

Neg. Loc.: Maryland Historical Trust
South room mantel

The south room has a mantel on the southwest wall that is identical to that in the east room. It has a small brick hearth. The fireplace opening has an infill of three vertical panels that appears to be original. The northwest wall has two doors, one to the north side and one to the west side. The doors themselves are later two panel doors, but the openings appear to be original. They apparently formerly led to the west room, but the west room has been altered and they now lead to a closet and a bathroom. The original west room had a wood mantel on the southwest wall with plain pilaster strips and a segmentally-arched frieze. This mantel survives in situ in the rearranged room that is now a bathroom.

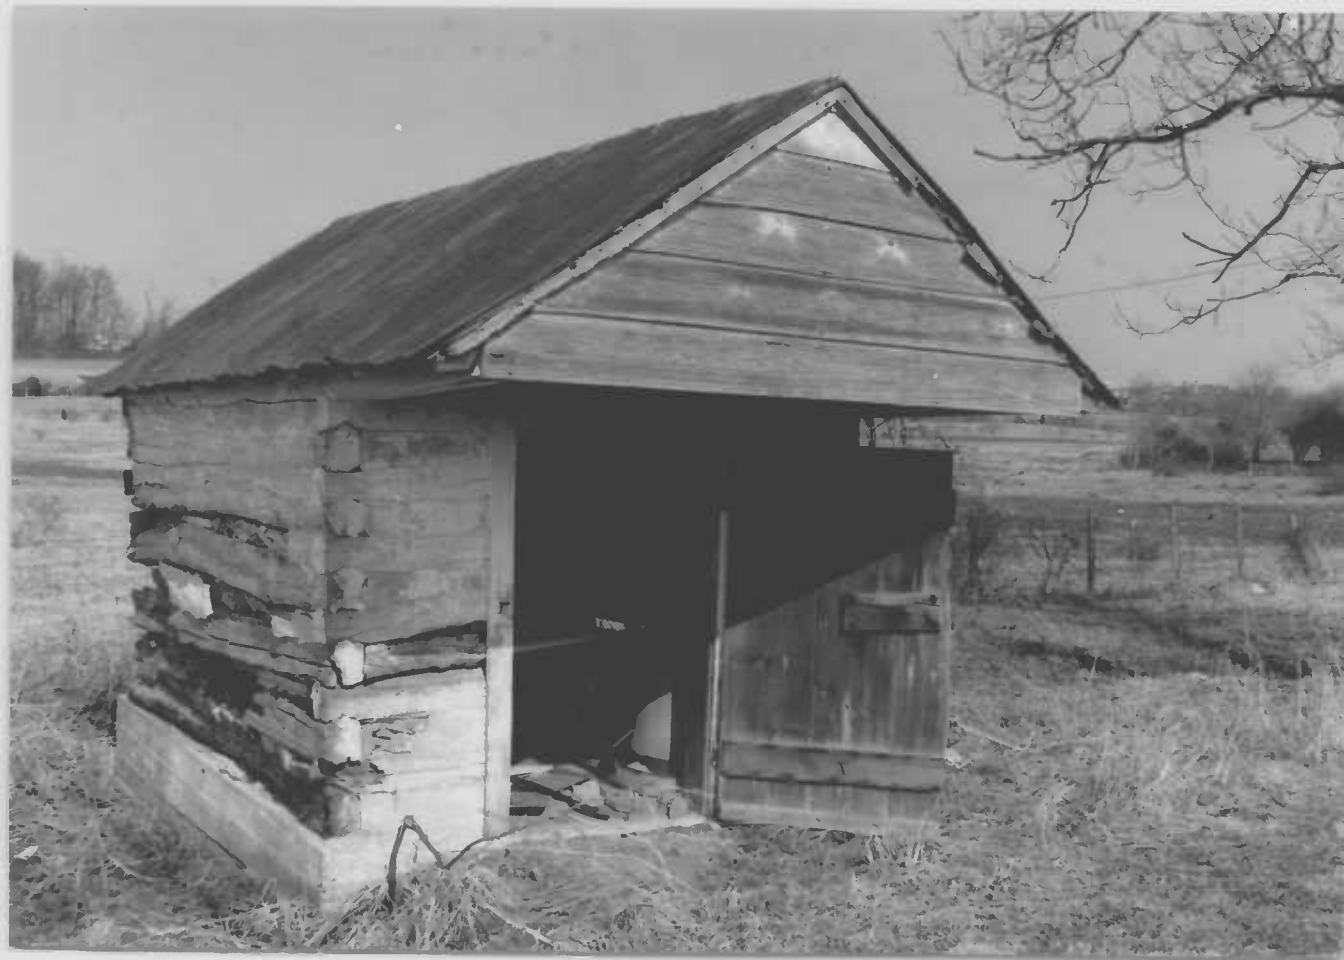
7/8

Neg. Loc.: Maryland Historical Trust
Smokehouse - NW & SW elevs.

About 30 feet north of the house is a log spring house with V-notch corners. It is set on a concrete foundation and may have been moved here. It is very deteriorated. The chinking is mostly of wood. It has a gable roof with an east-west ridge. It is cantilevered

on the west. The roofing has inverted V-seam metal. The logs are hewn on the sides. The top plate is hewn on all four sides. The rafter ends are exposed. The west elevation has a vertical-board door on strap hinges. The gable end has half-lap siding. The rafters are sawn, and have a half-lap and peg at the ridge. The interior has exposed logs and is blackened as if it was used for a smokehouse at some point. There are stones set in the ground as a walkway from this building to the rear elevation of the house suggesting that it may be in its original location.

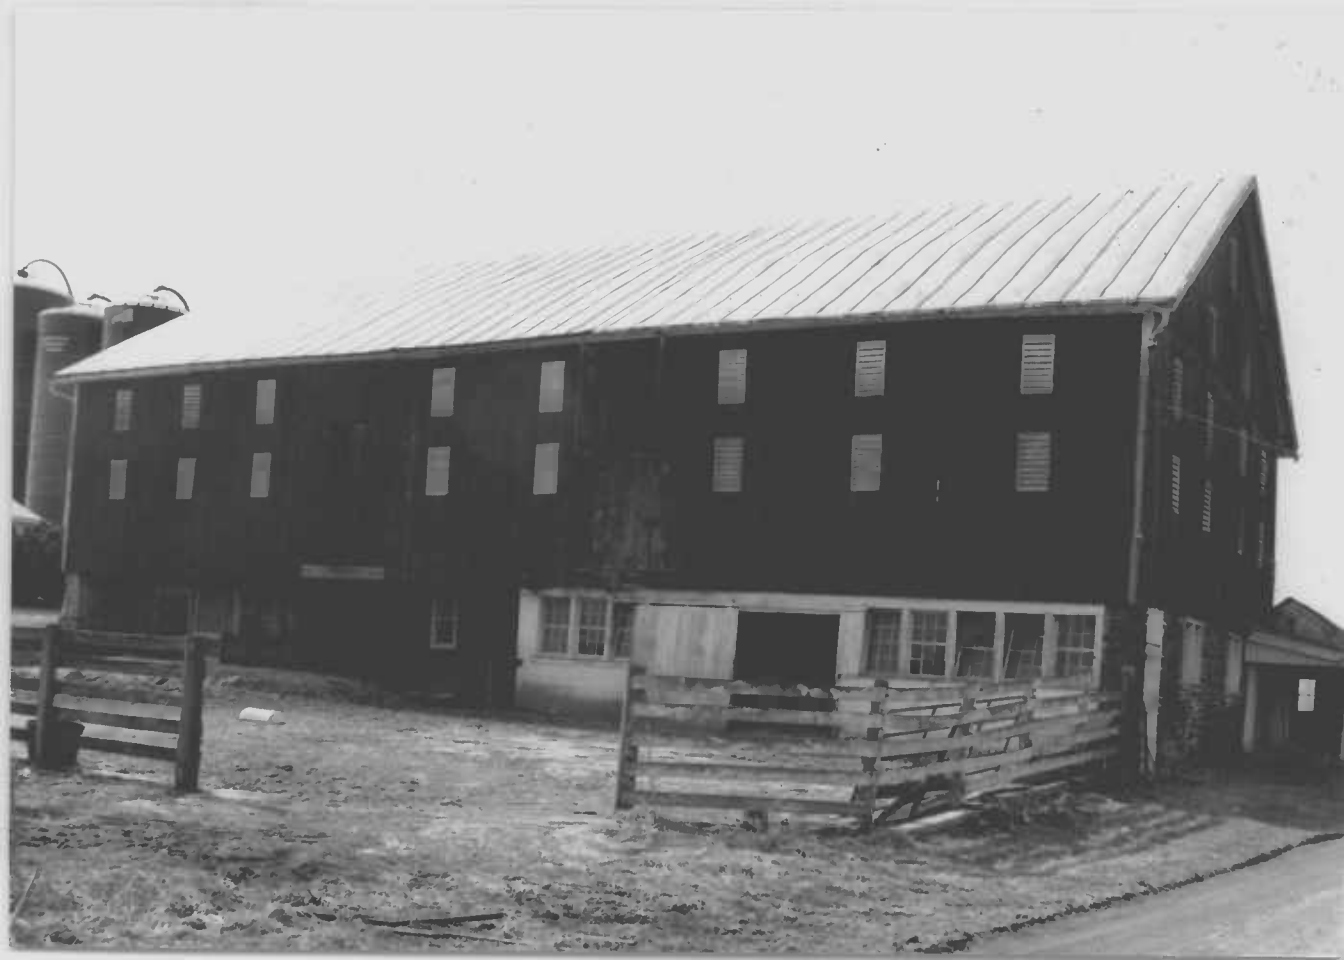
8/8

Neg. Loc.: Maryland Historical Trust
barn - SE elev.

About 100 feet southwest of the house is a bank barn with a forebay that faces southeast. The lower story has rubble stone on all four sides, with a stone end wall under each end of the forebay. The upper story has vertical-board siding, and the gable roof has standing-seam metal with a northeast-to-southwest ridge. The lower story of the southeast elevation has a Dutch door, a 4/? sash, an altered wide opening, a 4/? sash, a typical door, and a CMU addition under the forebay with twelve-light tilting sash. The upper story has three vents over three vents, double doors, two vents over two vents, double doors over double doors, and three vents over three vents.

The lower story northeast end of the barn has been altered as a dairy parlor. The southwest end has two hewn summer beams with four posts under each. The joists are, for the most part, reused timber. The wall by the ramp is partially collapsed. The upper story has two center threshing floors with a hay mow on each end and a granary in the north corner. There are five hewn bents that are mortised and tenoned and pegged, with four posts to each bent and a Queen post truss supporting the roof. There are sawn rafters that appear to be half lapped and pegged at the ridge. The bents have been considerably altered and have members cut out, and there is some deterioration to the barn.
